**Flood Control Project Maintenance
Levee Inspections**
LMA District Cover Sheet
Spring 2017 Levee Inspection Results

Reclamation District No. 2064 River Junction

Spring 2017 Levee Inspection Results

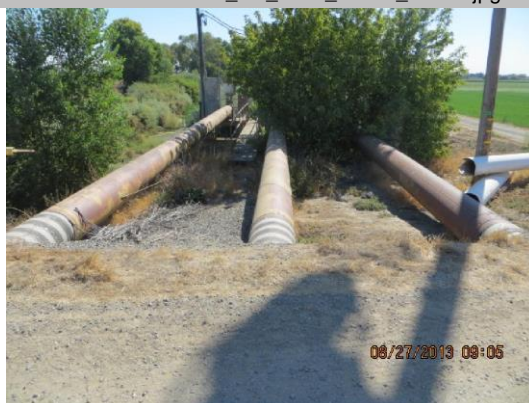
Photo 1 of 3 : UCIP_SP_2017_22729_38458.jpg

LM Start	0.06	Rating **	M	Issue No.	30 (cont)
LM End	0.06	Issue Type +	En	Location *	LS

Pipe visible on LS.

LM Start	0.06	Rating **	M	Issue No.	30 (cont)
LM End	0.06	Issue Type +	En	Location *	LS
Category	Supplemental			GPS Latitude/Longitude	
				Start	End
Item	DWR UCIP Field Study			37.709698 °	37.709698 °
				-121.267536 °	-121.267536 °
DWR ID					
Comment Code					
Inspector Comment					
FS_ID:22729					
DS_ID:20527					
EP_NO: 13907					
Repair Type: Non-Urgent					
Crossing Status: Found					
UCIP Comments: This pipe has less than 1-foot of cover.					
FIELD_STRUCT_DESC: 2 of 3: 24-inch steel stormdrain discharge pipe					
through the levee 2.0 feet below the crown (Permit No. 13907, 1985).					
Two 100-horsepower and one 75-horsepower pumps on pier at					
landward toe of levee. Siphon breaker on WS shoulder.					
FS Date: 8/27/2013

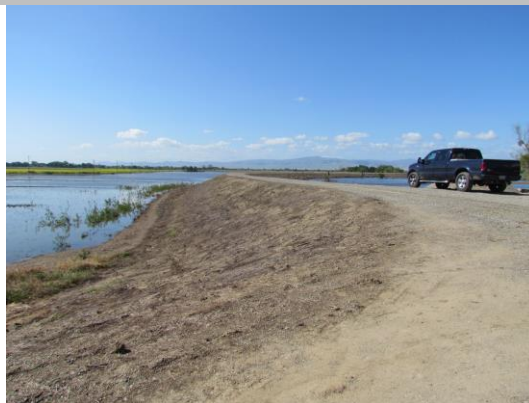
Photo 1 of 1 : SP_2017_RD2064_313_22_20170517_00044.jpg

LM Start	0.08	Rating **	A	Issue No.	22
LM End	5.53	Issue Type +	Ma	Location *	LS
Category	Earthen Levee			GPS Latitude/Longitude	
				Start	End
Item	Vegetation			37.709490 °	37.667562 °
				-121.267525 °	-121.241075 °
DWR ID	DWR_RD2064_01_s_2017_22				
Comment Code					
V1 : Control annual grass and weeds on the levee slopes and easements.					
Inspector Comment					
There is no unwanted vegetation levee mile 0.08-5.53.

Looking upstream from levee mile 0.08 landside slope.

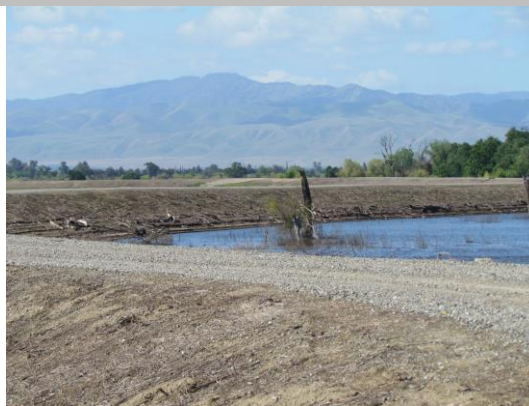
Photo 1 of 1 : SP_2017_RD2064_313_23_20170424_00043.jpg

LM Start	0.08	Rating **	A	Issue No.	23
LM End	5.53	Issue Type +	Ma	Location *	WS
Category	Earthen Levee			GPS Latitude/Longitude	
				Start	End
Item	Vegetation			37.709490 °	37.667562 °
				-121.267525 °	-121.241075 °
DWR ID	DWR_RD2064_01_s_2017_23				
Comment Code					
V1 : Control annual grass and weeds on the levee slopes and easements.					
Inspector Comment					
No unwanted vegetation on the water slope from levee mile 0.08-5.53.

Standing at levee mile 0.08 looking upstream.

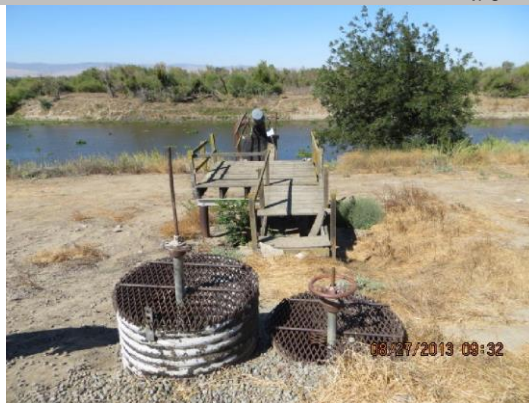
Photo 1 of 3 : UCIP_SP_2017_40792_31377.jpg

LM Start	1.23	Rating **	M	Issue No.	32
LM End	1.23	Issue Type +	En	Location *	WS
Category	Supplemental			GPS Latitude/Longitude	
				Start	End
Item	DWR UCIP Field Study			37.695529 °	37.695529 °
				-121.270005 °	-121.270005 °
DWR ID					
Comment Code					
Inspector Comment					
FS_ID:40792 DS_ID:20533 EP_NO: N/A Repair Type: Non-Urgent Crossing Status: Found UCIP Comments: Pump and slant pipe missing from structure on WS slope. FIELD_STRUCT_DESC: 12-inch steel concrete encased irrigation pipe through the levee 13.0 feet below the crown, slant pump on the WS toe. Slide gate in 36-inch CMP riser on the WS shoulder. 6'X6' concrete distribution box and filter plant on LS toe. 2-inch galvanized iron electrical conduit at same location. Originally included in the 1968 O&M manual. FS Date: 8/27/2013

Slide gate in CMP riser on WS shoulder.

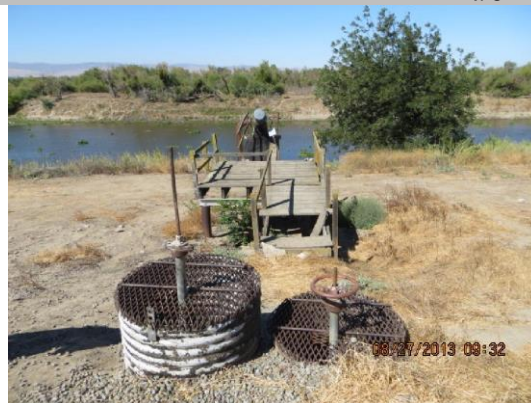
Photo 1 of 3 : UCIP_SP_2017_51638_38462.jpg

FS_ID:51638
DS_ID:20524
EP_NO: 3739
Repair Type: Urgent
Crossing Status: Found
UCIP Comments: 11/16/2016 same as last inspection leak has created sink hole near concrete distribution box located on the LS. Hole in pipe is visible at sink hole. Need to contact owner to address leak on LS. Recommend an internal inspection be completed for the pipe through the levee to determine pipe integrity. (O. Magana - DWR UCIP)08/27/2013 Some leakage at connection between pipe and distro box on LS toe. This may indicate internal failure of pipe. (W. Wylie - DWR UCIP)
FIELD_STRUCT_DESC: 16-inch steel irrigation pipe through the levee, 10.75 feet below the crown. 2-inch galvanized iron electrical conduit at same location. Slant pump is located on the waterside (WS) toe. Slide gate in 36-inch corrugated metal pipe (CMP) riser is located on the WS shoulder. 6-foot by 6-foot concrete distribution box and filter plant are located on landside (LS) toe. (16-inch pipe authorized under Permit No. 3739, 1961 - Mortensen & Barker)

LM Start	1.23	Rating **	U	Issue No.	33 (cont)
LM End	1.23	Issue Type +	En	Location *	WS

Slant pump on WS toe. Slide gate in 36-inch CMP riser on WS shoulder.

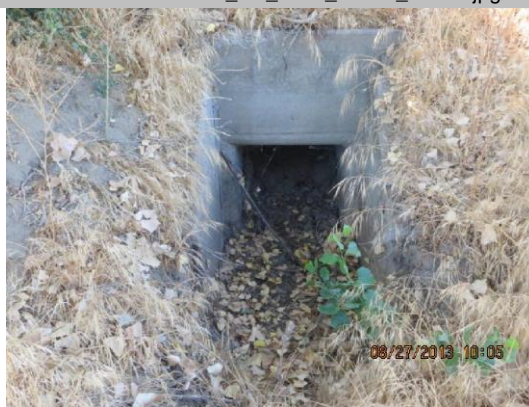
Photo 3 of 3 : UCIP_SP_2017_18763_31400.jpg

Concrete U-shaped headwall on LS toe.

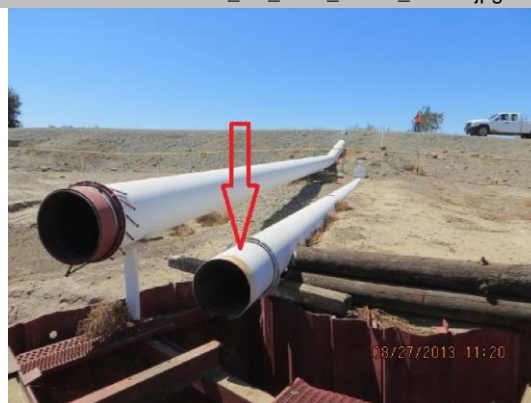
Photo 2 of 3 : UCIP_SP_2017_19044_31843.jpg

LM Start	3.57	Rating **	M	Issue No.	39 (cont)
LM End	3.57	Issue Type +	En	Location *	WS
Category	Supplemental			GPS Latitude/Longitude	
				Start	End
Item	DWR UCIP Field Study			37.675267 °	37.675267 °
				-121.263426 °	-121.263426 °
DWR ID					
Comment Code					
Inspector Comment					
FS_ID:19044 DS_ID:20519 EP_NO: 6450 Repair Type: Non-Urgent Crossing Status: Found UCIP Comments: Appears abandoned and if so should be done so properly. FIELD_STRUCT_DESC: *ABANDONED* 18-inch steel discharge pipe through the levee 2-feet below the crown. Crown roadway padded over the pipe. Pipe exposed on both slopes. Gate valve on the LS toe. Pump missing from sump with sheet pile siding in ditch on the landside. Siphon breaker on the waterward side (Permit No. 6450, 1969). FS Date: 8/27/2013

Pipe visible at sump off LS toe. No pump or appurtenances.

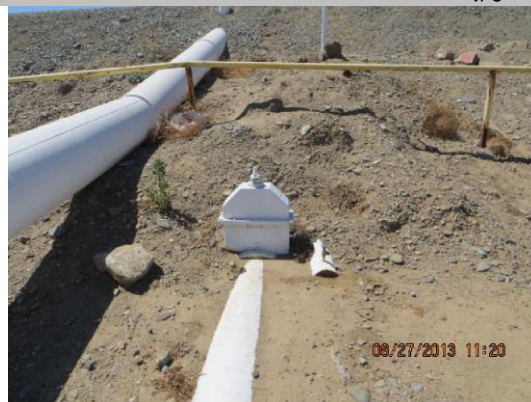
Photo 3 of 3 : UCIP_SP_2017_19044_31842.jpg

Gate valve on LS toe.

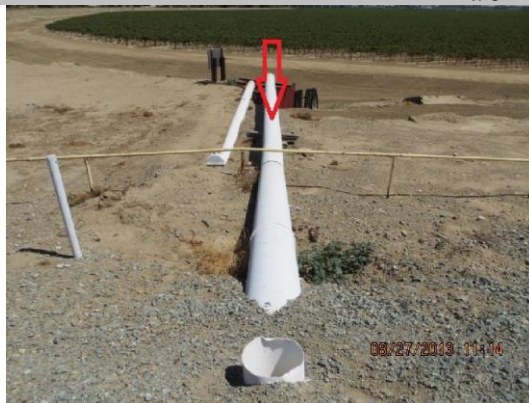
Photo 1 of 3 : UCIP_SP_2017_22733_38468.jpg

Pipe and vent visible on LS slope.

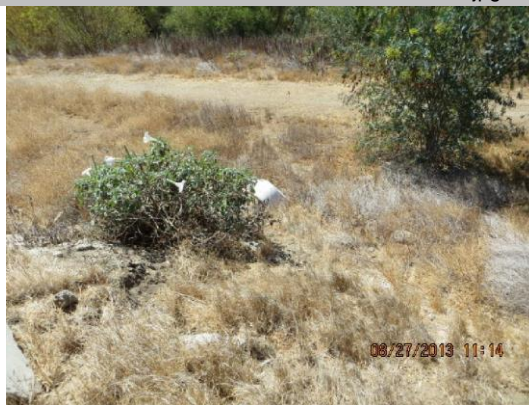
Photo 2 of 3 : UCIP_SP_2017_22733_38467.jpg

Pipe visible on WS slope.

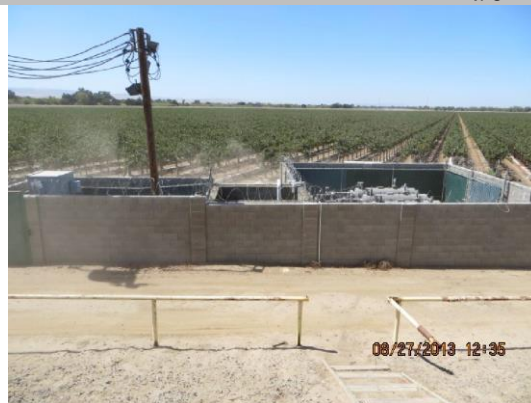
Photo 1 of 2 : UCIP_SP_2017_19063_31861.jpg

Concrete distribution box remains in center of structure on LS toe.

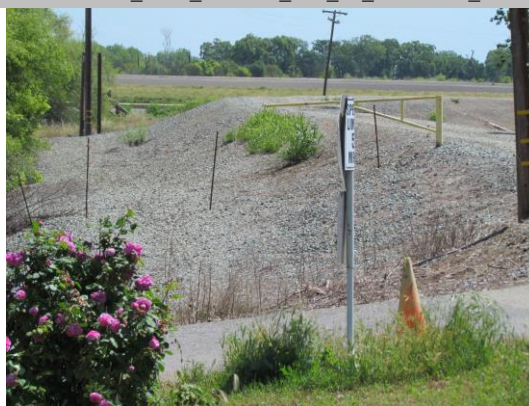
Photo 1 of 1 : SP_2017_RD2064_314_18_20170518_00048.jpg

LM Start	0.00	Rating **	A	Issue No.	18
LM End	0.33	Issue Type +	Ma	Location *	LS
Category	Earthen Levee			GPS Latitude/Longitude	
				Start	End
Item	Vegetation			37.667078 °	37.664752 °
				-121.240990 °	-121.236510 °
DWR ID	DWR_RD2064_02_s_2017_18				
Comment Code					
V1 : Control annual grass and weeds on the levee slopes and easements.					
Inspector Comment					
No unwanted vegetation within this levee section.

RD 2064 looking upstream from the landside shoulder.

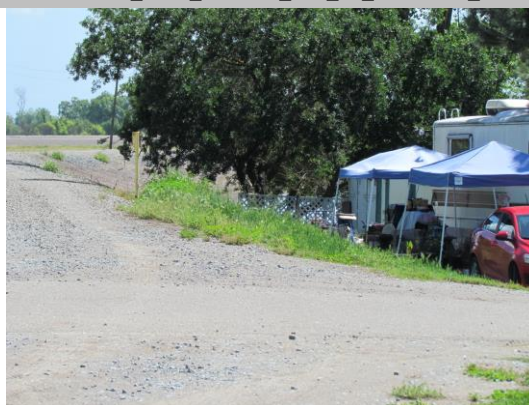
Photo 1 of 1 : SP_2017_RD2064_314_24_20170517_00046.jpg

LM Start	0.00	Rating **	M	Issue No.	24
LM End	4.20	Issue Type +	Ma	Location *	WS
Category	Earthen Levee			GPS Latitude/Longitude	
				Start	End
Item	Vegetation			37.667078 °	37.695335 °
				-121.240992 °	-121.206227 °
DWR ID	DWR_RD2064_02_s_2017_24				
Comment Code					
V1 : Control annual grass and weeds on the levee slopes and easements.					
Inspector Comment					
There is no unwanted vegetation from levee mile 0.00-4.20 waterside.

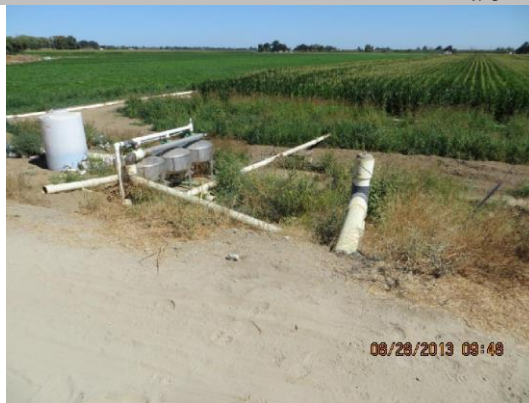
Photo 1 of 3 : UCIP_SP_2017_44653_37715.jpg

Pipe, vent, and filter plant on LS shoulder and LS toe.

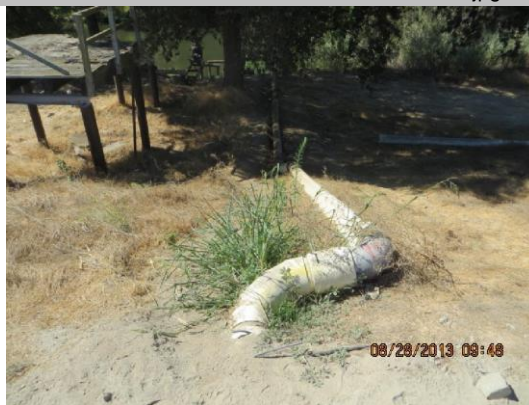
Photo 2 of 3 : UCIP_SP_2017_44653_37714.jpg

Pipe visible on WS shoulder/slope.

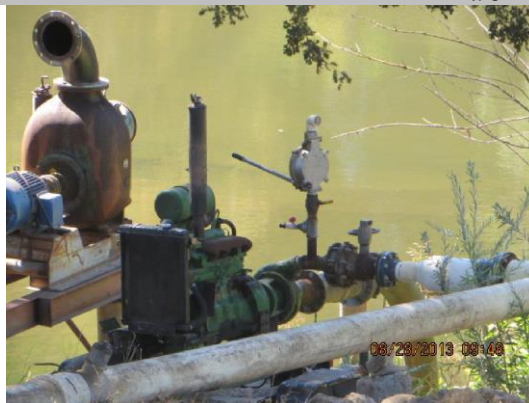
Photo 3 of 3 : UCIP_SP_2017_44653_37713.jpg

LM Start	0.33	Rating **	M	Issue No.	25 (cont)	
LM End	0.33	Issue Type +	En	Location *	WS	
Category	Supplemental			GPS Latitude/Longitude		
				Start		End
Item	DWR UCIP Field Study			37.664752 °		37.664752 °
				-121.236512 °		-121.236512 °
DWR ID						
Comment Code						
Inspector Comment						
FS_ID:44653						
DS_ID:24062						
EP_NO: N/A						
Repair Type: Non-Urgent						
Crossing Status: Found						
UCIP Comments: Plan of action in progress to install permanant pipe and pump by August 2015. No permit identified for large PVC irrigation pipe with inadequate cover.						
FIELD_STRUCT_DESC: 8-inch PVC irrigation pipe through the levee 0.5-feet below the crown. Portable pump on the WS berm and a filter plant on the LS toe. Vent at filter plant on LS toe.						
FS Date: 4/22/2015

Portable pump on WS berm.

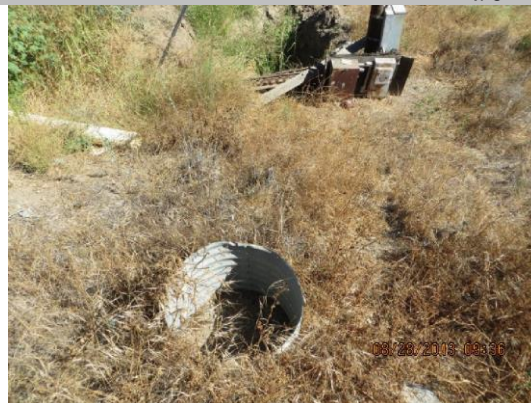
Photo 1 of 3 : UCIP_SP_2017_51385_31892.jpg

Siphon breaker in 24-inch CMP riser on LS shoulder.

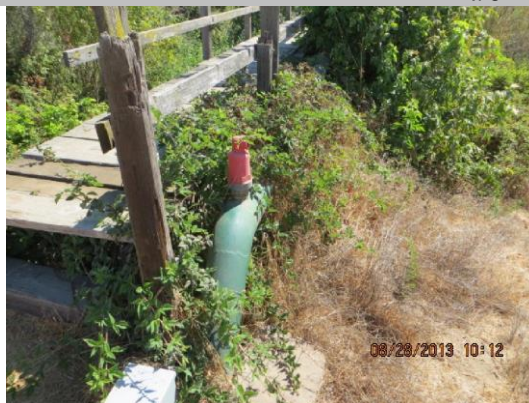
Photo 1 of 3 : UCIP_SP_2017_22095_37722.jpg

LM Start	1.97	Rating **	M	Issue No.	27
LM End	1.97	Issue Type +	En	Location *	LS
Category	Supplemental			GPS Latitude/Longitude	
				Start	End
Item	DWR UCIP Field Study			37.676454 °	37.676454 °
				-121.223204 °	-121.223204 °
DWR ID					
Comment Code					
Inspector Comment					
FS_ID:22095					
DS_ID:24063					
EP_NO: N/A					
Repair Type: Non-Urgent					
Crossing Status: Found					
UCIP Comments: No permit identified for this crossing.					
FIELD_STRUCT_DESC: 6-inch steel irrigation pipe through the levee at unknown depth below the crown. Pump on wooden pier at WS . Vent between 2 steel bollards on LS shoulder. Filter plant on LS toe. 1.5-inch galvanized iron electrical conduit at same location.					
FS Date: 8/27/2013

Pipe and vent visible on WS shoulder at wooden walkway.

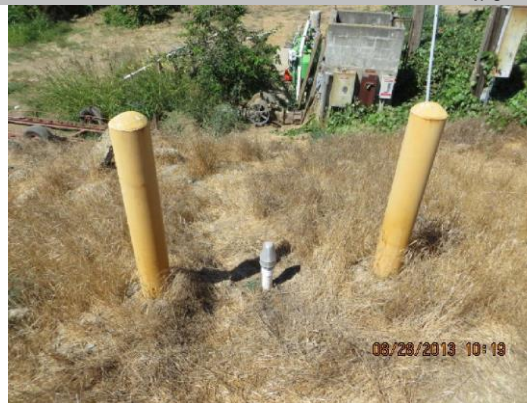
Photo 2 of 3 : UCIP_SP_2017_22095_37721.jpg

Vent on LS shoulder.

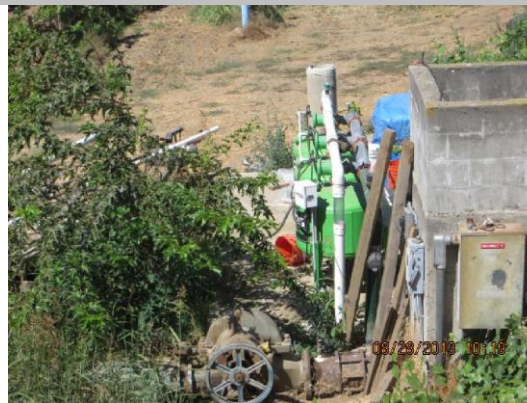
Photo 3 of 3 : UCIP_SP_2017_22095_37720.jpg

Filterplant visible on LS toe.

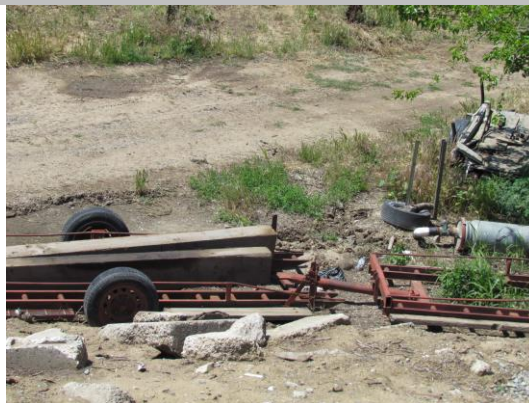
Photo 1 of 2 : SP_2017_RD2064_314_23_20170518_00050.jpg

LM Start	1.97	Rating **	U	Issue No.	23
LM End	1.97	Issue Type +	En	Location *	LS
Category	Earthen Levee			GPS Latitude/Longitude	
				Start	End
Item	Encroachments			37.676454 °	37.676454 °
				-121.223200 °	-121.223200 °
DWR ID	DWR_RD2064_02_s_2017_23				
Comment Code					
EQ : Equipment					
Inspector Comment					
This equipment and other materials need to be removed from the landside easement.

RD 2064 Landside looking upstream from levee mile 1.97 equipment on the berm.

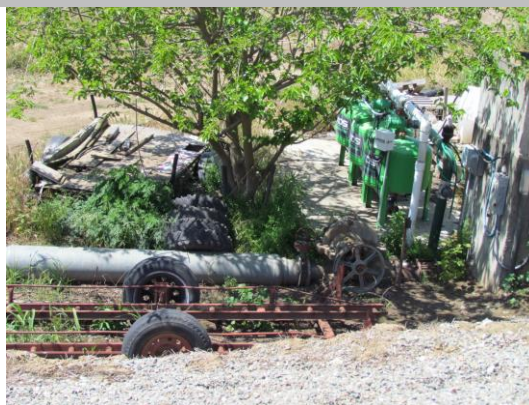
Photo 2 of 2 : SP_2017_RD2064_314_23_20170518_00051.jpg

RD 2064 Landside looking upstream from levee mile 1.97 more equipment and other materials within the easement.

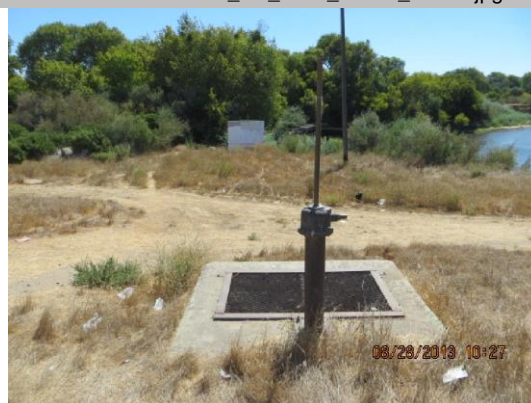
Photo 1 of 3 : UCIP_SP_2017_19086_31954.jpg

Gate valve on WS shoulder. Pump next to concrete riser in background.

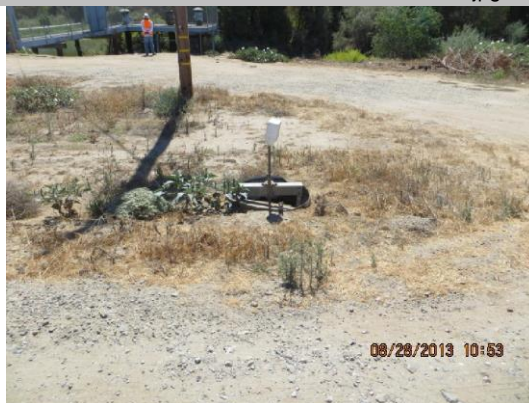
Photo 2 of 3 : UCIP_SP_2017_41075_31962.jpg

Slide gate in 36-inch CMP riser on WS slope.

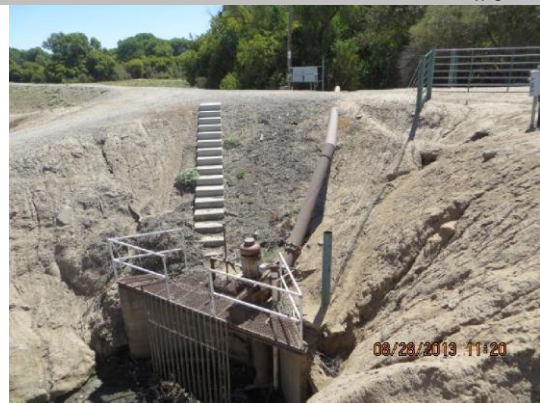
Photo 1 of 2 : UCIP_SP_2017_22107_37736.jpg

LM Start	4.24	Rating **	M	Issue No.	30
LM End	4.24	Issue Type +	En	Location *	LS
Category	Supplemental			GPS Latitude/Longitude	
				Start	End
Item	DWR UCIP Field Study			37.695745 °	37.695745 °
				-121.205865 °	-121.205865 °
DWR ID					
Comment Code					
Inspector Comment					
FS_ID:22107					
DS_ID:24064					
EP_NO: N/A					
Repair Type: Non-Urgent					
Crossing Status: Found					
UCIP Comments: Pipe does not have adequate cover at crown.					
FIELD_STRUCT_DESC: 12-inch steel discharge pipe through the levee					
0.5-feet below the crown. Pump on concrete headwall at LS toe. Pipe					
discharges into 6'X7' concrete box on WS shoulder.					
FS Date: 8/28/2013

Pump for pipe on concrete headwall at LS toe.

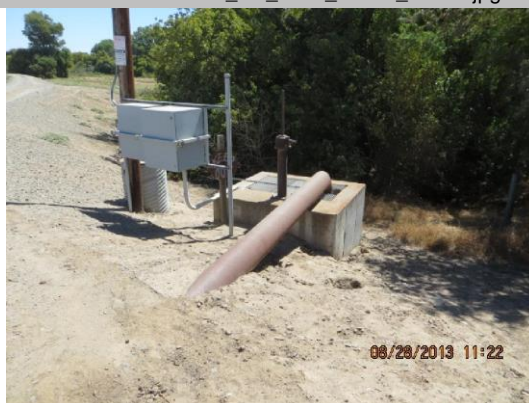
Photo 2 of 2 : UCIP_SP_2017_22107_37735.jpg

Pipe discharges into concrete riser on WS slope.

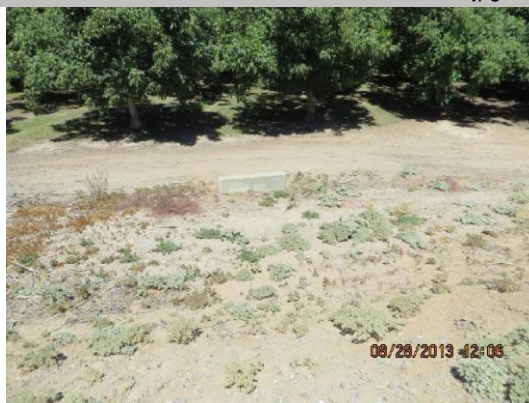
Photo 1 of 3 : UCIP_SP_2017_19117_32069.jpg

LM Start	4.41	Rating **	A/W	Issue No.	31
LM End	4.41	Issue Type +	Ma	Location *	LS
Category	Supplemental			GPS Latitude/Longitude	
				Start	End
Item	DWR UCIP LMA Responsibility			37.696386 °	37.696386 °
				-121.202963 °	-121.202963 °
DWR ID					
Comment Code					
Inspector Comment					
FS_ID:19117					
DS_ID:20549					
EP_NO: N/A					
Repair Type: No Action Needed					
Crossing Status: Found					
UCIP Comments:					
FIELD_STRUCT_DESC: 30-inch pipe through the levee 10.5-feet below the crown. Concrete "U" shaped headwalls on both ends. Flap gate on the waterward end. Two corrugated metal cutoff walls. Originally included in the 1968 O&M manual.					
FS Date: 8/28/2013

Headwall on LS toe.

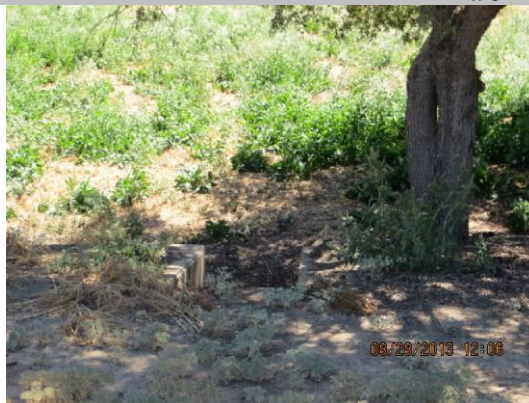
Photo 2 of 3 : UCIP_SP_2017_19117_32068.jpg

Headwall on WS toe.

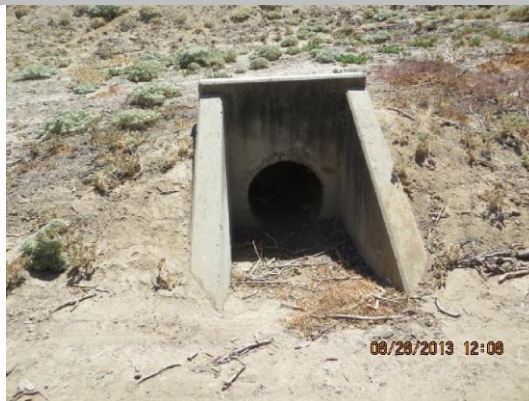
Photo 3 of 3 : UCIP_SP_2017_19117_32067.jpg

Headwall on LS toe.

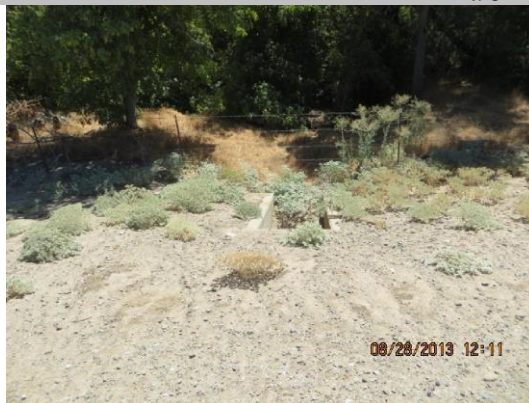
Photo 1 of 3 : UCIP_SP_2017_22793_38842.jpg

LM Start	4.51	Rating **	A/W	Issue No.	32
LM End	4.51	Issue Type +	Ma	Location *	LS
Category	Supplemental			GPS Latitude/Longitude	
				Start	End
Item	DWR UCIP LMA Responsibility			37.696892 °	37.696892 °
				-121.201228 °	-121.201228 °
DWR ID					
Comment Code					
Inspector Comment					
FS_ID:22793					
DS_ID:20550					
EP_NO: N/A					
Repair Type: No Action Needed					
Crossing Status: Found					
UCIP Comments:					
FIELD_STRUCT_DESC: 30-inch corrugated metal stormdrain pipe through the levee 8.0-feet below the crown. Concrete "U" shaped headwalls on both ends and flap gate on the waterward end. Grouted spill way on the waterward side. Originally included in the 1968 O&M manual.					
FS Date: 8/28/2013

Concrete headwall on WS toe.

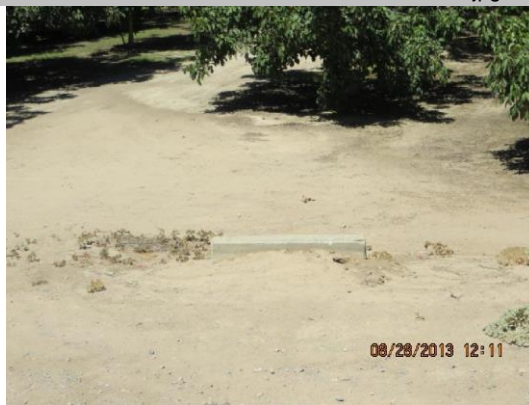
Photo 2 of 3 : UCIP_SP_2017_22793_38841.jpg

Concrete headwall on LS toe.

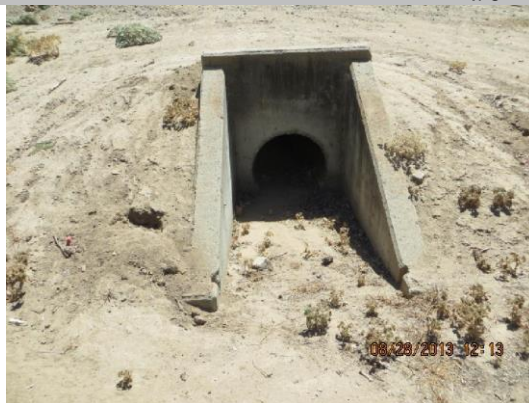
Photo 3 of 3 : UCIP_SP_2017_22793_38844.jpg

Concrete headwall on LS toe.

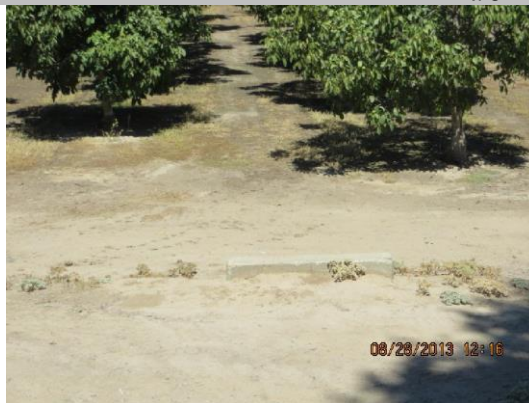
Photo 1 of 3 : UCIP_SP_2017_19120_32079.jpg

LM Start	4.64	Rating **	A/W	Issue No.	33
LM End	4.64	Issue Type +	Ma	Location *	LS
Category	Supplemental			GPS Latitude/Longitude	
				Start	End
Item	DWR UCIP LMA Responsibility			37.697101 °	37.697101 °
				-121.199048 °	-121.199048 °
DWR ID					
Comment Code					
Inspector Comment					
FS_ID:19120 DS_ID:20551 EP_NO: N/A Repair Type: No Action Needed Crossing Status: Found UCIP Comments: FIELD_STRUCT_DESC: 30-inch corrugated metal stormdrain pipe through the levee 10.0-feet below the crown. Concrete "U" shaped headwall on both ends. Flap gate on the waterward end. Two corrugated metal cutoff walls. Grouted spill way on the waterward side. Spill way damaged due to uprooted tree. Originally included in the 1968 O&M manual. FS Date: 8/28/2013

Concrete headwall on LS toe.

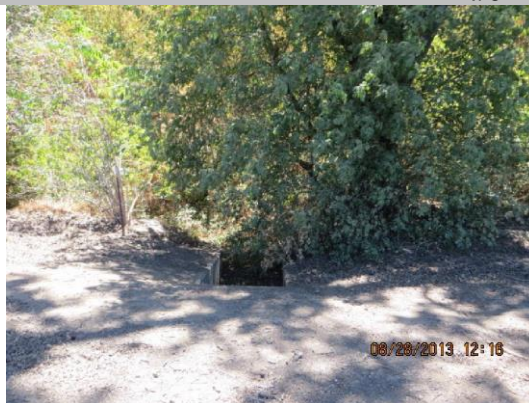
Photo 2 of 3 : UCIP_SP_2017_19120_32078.jpg

Concrete headwall on WS toe.

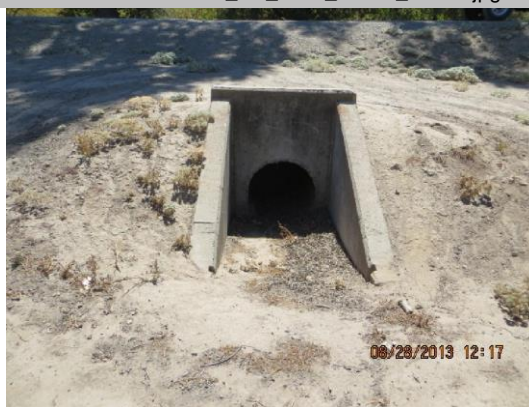
Photo 3 of 3 : UCIP_SP_2017_19120_32077.jpg

Concrete headwall on LS toe.

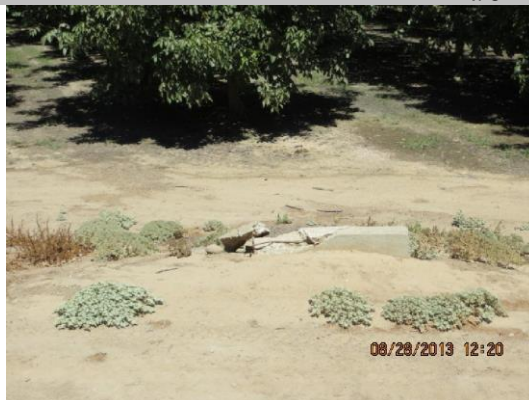
Photo 1 of 3 : UCIP_SP_2017_19122_32083.jpg

LM Start	4.78	Rating **	A/W	Issue No.	34
LM End	4.78	Issue Type +	Ma	Location *	LS
Category	Supplemental			GPS Latitude/Longitude	
				Start	End
Item	DWR UCIP LMA Responsibility			37.696888 °	37.696888 °
				-121.196511 °	-121.196511 °
DWR ID					
Comment Code					
Inspector Comment					
FS_ID:19122					
DS_ID:20552					
EP_NO: N/A					
Repair Type: No Action Needed					
Crossing Status: Found					
UCIP Comments:					
FIELD_STRUCT_DESC: 30-inch corrugated metal stormdrain pipe					
through the levee 8.5 feet below the crown. Concrete "U" shaped					
headwall on both ends. Flap gate on the waterward end. Two					
corrugated metal cutoff walls and grouted spillway on the waterward					
side. Originally included in the 1968 O&M manual.					
FS Date: 8/28/2013

Concrete headwall on LS toe.

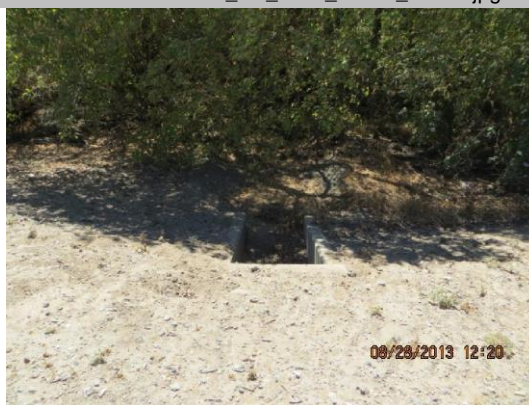
Photo 2 of 3 : UCIP_SP_2017_19122_32082.jpg

Concrete headwall on WS toe.

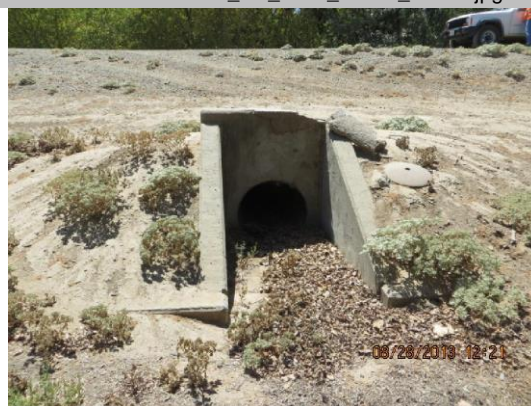
Photo 3 of 3 : UCIP_SP_2017_19122_32081.jpg

Concrete headwall on LS toe.

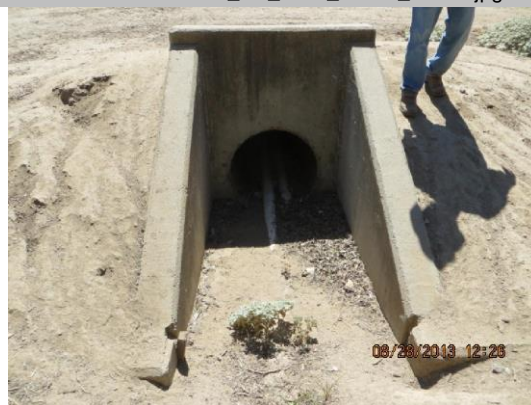
Photo 1 of 3 : UCIP_SP_2017_22108_37739.jpg

LM Start	4.92	Rating **	M	Issue No.	35
LM End	4.92	Issue Type +	En	Location *	LS
Category	Supplemental			GPS Latitude/Longitude	
				Start	End
Item	DWR UCIP Field Study			37.696146 °	37.696146 °
				-121.194093 °	-121.194093 °
DWR ID					
Comment Code					
Inspector Comment					
FS_ID:22108 DS_ID:24065 EP_NO: N/A Repair Type: Non-Urgent Crossing Status: Found UCIP Comments: No permit identified for this discharge pipe. FIELD_STRUCT_DESC: 1 of 2: 4-inch PVC discharge pipe through the 30-inch stormdrain pipe 11-feet below the crown. No permit. FS Date: 8/28/2013

PVC pipe at right inside stormdrain on LS toe.

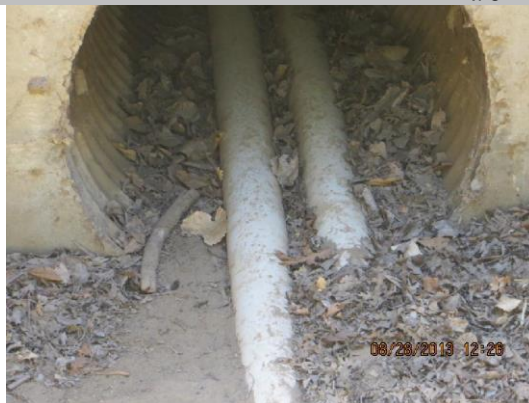
Photo 2 of 3 : UCIP_SP_2017_22108_37738.jpg

PVC pipe at right inside stormdrain on LS toe.

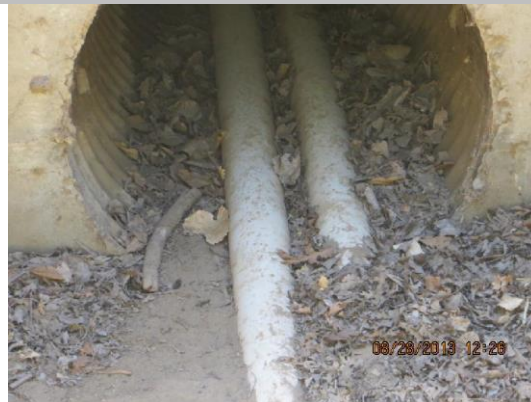
Photo 2 of 3 : UCIP_SP_2017_22109_37741.jpg

FS_ID:22109
DS_ID:24066
EP_NO: N/A
Repair Type: Non-Urgent
Crossing Status: Found
UCIP Comments: No permit identified for this crossing.
FIELD_STRUCT_DESC: 2 of 2: 4-inch PVC discharge pipe through the 30-inch stormdrain pipe 11-feet below the crown. No permit.
FS Date: 8/28/2013

PVC conduit at left on LS toe.

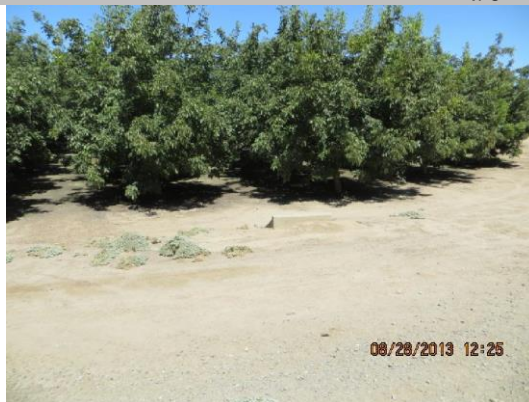
Photo 1 of 3 : UCIP_SP_2017_19143_32122.jpg

LM Start	4.92	Rating **	A/W	Issue No.	37
LM End	4.92	Issue Type +	Ma	Location *	LS
Category	Supplemental			GPS Latitude/Longitude	
				Start	End
Item	DWR UCIP LMA Responsibility			37.696146 °	37.696146 °
				-121.194093 °	-121.194093 °
DWR ID					
Comment Code					
Inspector Comment					
FS_ID:19143					
DS_ID:20553					
EP_NO: N/A					
Repair Type: No Action Needed					
Crossing Status: Found					
UCIP Comments:					
FIELD_STRUCT_DESC: 30-inch CMP stormdrain pipe through the levee 8.0 feet below the crown. Concrete "U" headwall on both ends. Flap gate on the waterward end. Two corrugated metal cutoff walls. Grouted spillway on the waterward side. Originally included in the 1968 O&M manual.					
FS Date: 8/28/2013

Concrete headwall on LS toe.

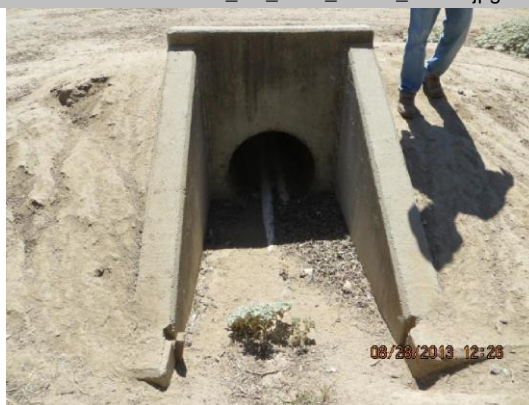
Photo 3 of 3 : UCIP_SP_2017_19143_32120.jpg

Concrete headwall on LS toe.

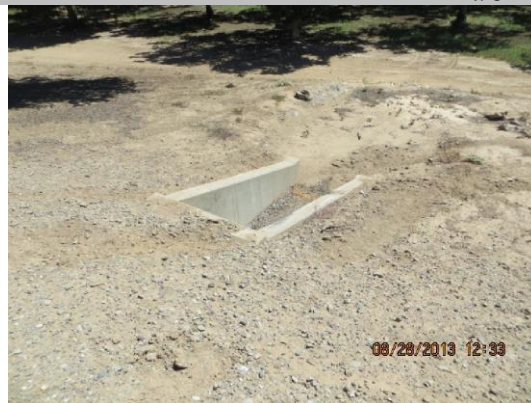
Photo 1 of 3 : UCIP_SP_2017_22794_38851.jpg

LM Start	5.10	Rating **	A/W	Issue No.	38
LM End	5.10	Issue Type +	Ma	Location *	LS
Category	Supplemental			GPS Latitude/Longitude	
				Start	End
Item	DWR UCIP LMA Responsibility			37.697483 °	37.697483 °
				-121.191332 °	-121.191332 °
DWR ID					
Comment Code					
Inspector Comment					
FS_ID:22794					
DS_ID:20554					
EP_NO: N/A					
Repair Type: No Action Needed					
Crossing Status: Found					
UCIP Comments:					
FIELD_STRUCT_DESC: 30-inch corrugated metal stormdrain pipe through the levee 8.0-feet below the crown. Concrete "U" headwall on both ends. Flap gate on the waterward end. Two corrugated metal cutoff walls. Grouted spillway on the waterward side. Originally included in the 1968 O&M manual.					
FS Date: 8/28/2013

Concrete U shaped headwall on WS toe.

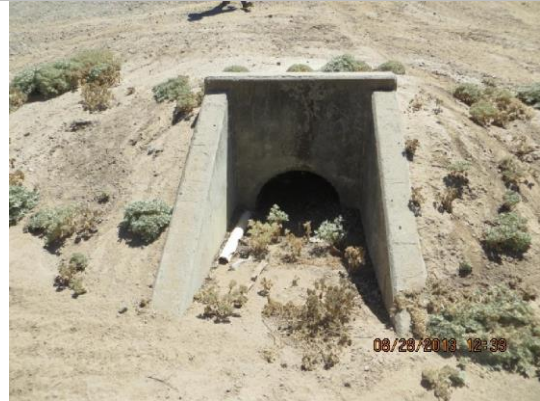
Photo 3 of 3 : UCIP_SP_2017_22794_38853.jpg

Concrete headwall on LS toe.
